Soil-The Critical Element in Stormwater Design

Robert G. Traver, Ph.D., PE, D.WRE

Villanova Urban Stormwater Partnership **VUSP**
Department of Civil and Environmental Engineering

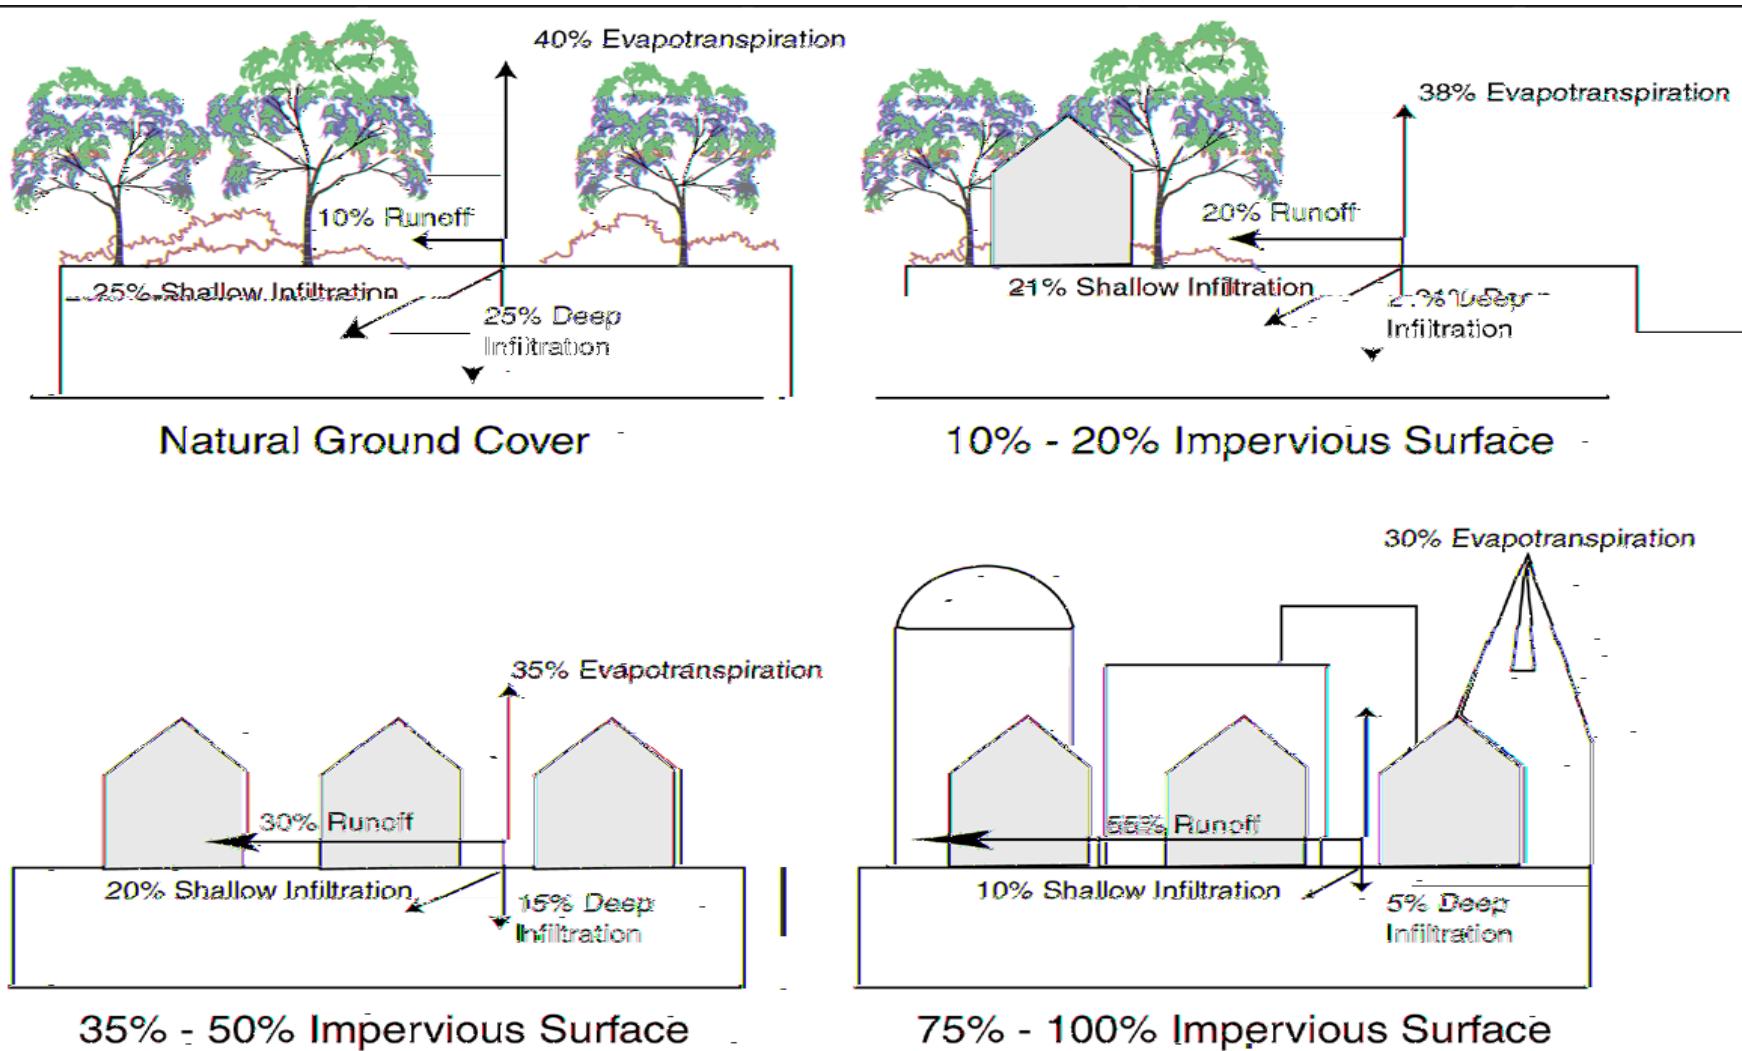
Imperviousness vs. Runoff

Changes in runoff flow resulting from increased impervious area (NC Dept. of Nat. Res. and Community Dev., in Livingston and McCarron, 1992.)

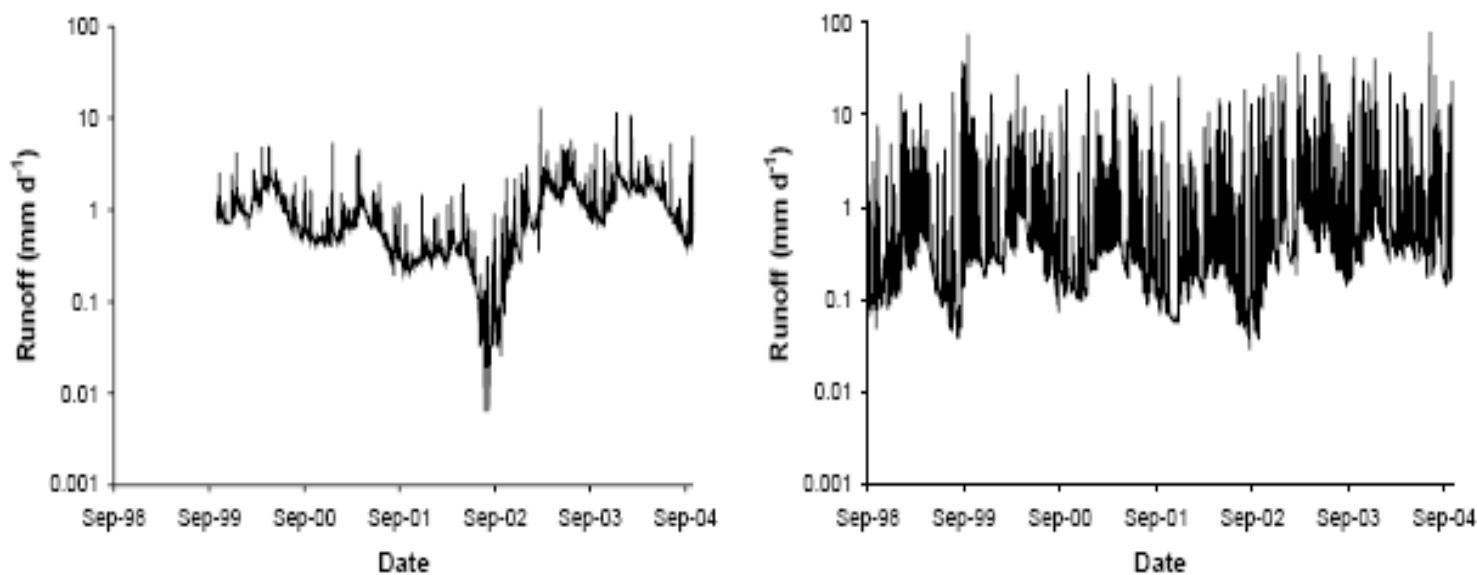
FIGURE 3-12 Daily time series of flows in (A) a low-density suburban and forested catchment (Baisman Run, http://waterdata.usgs.gov/md/nwis/uv/?site_no=01583580) and (B) a catchment dominated by medium-to-high density residential land cover (Rock Run, http://waterdata.usgs.gov/md/nwis/uv/?site_no=01583581). Both lie within the Piedmont physiographic province.

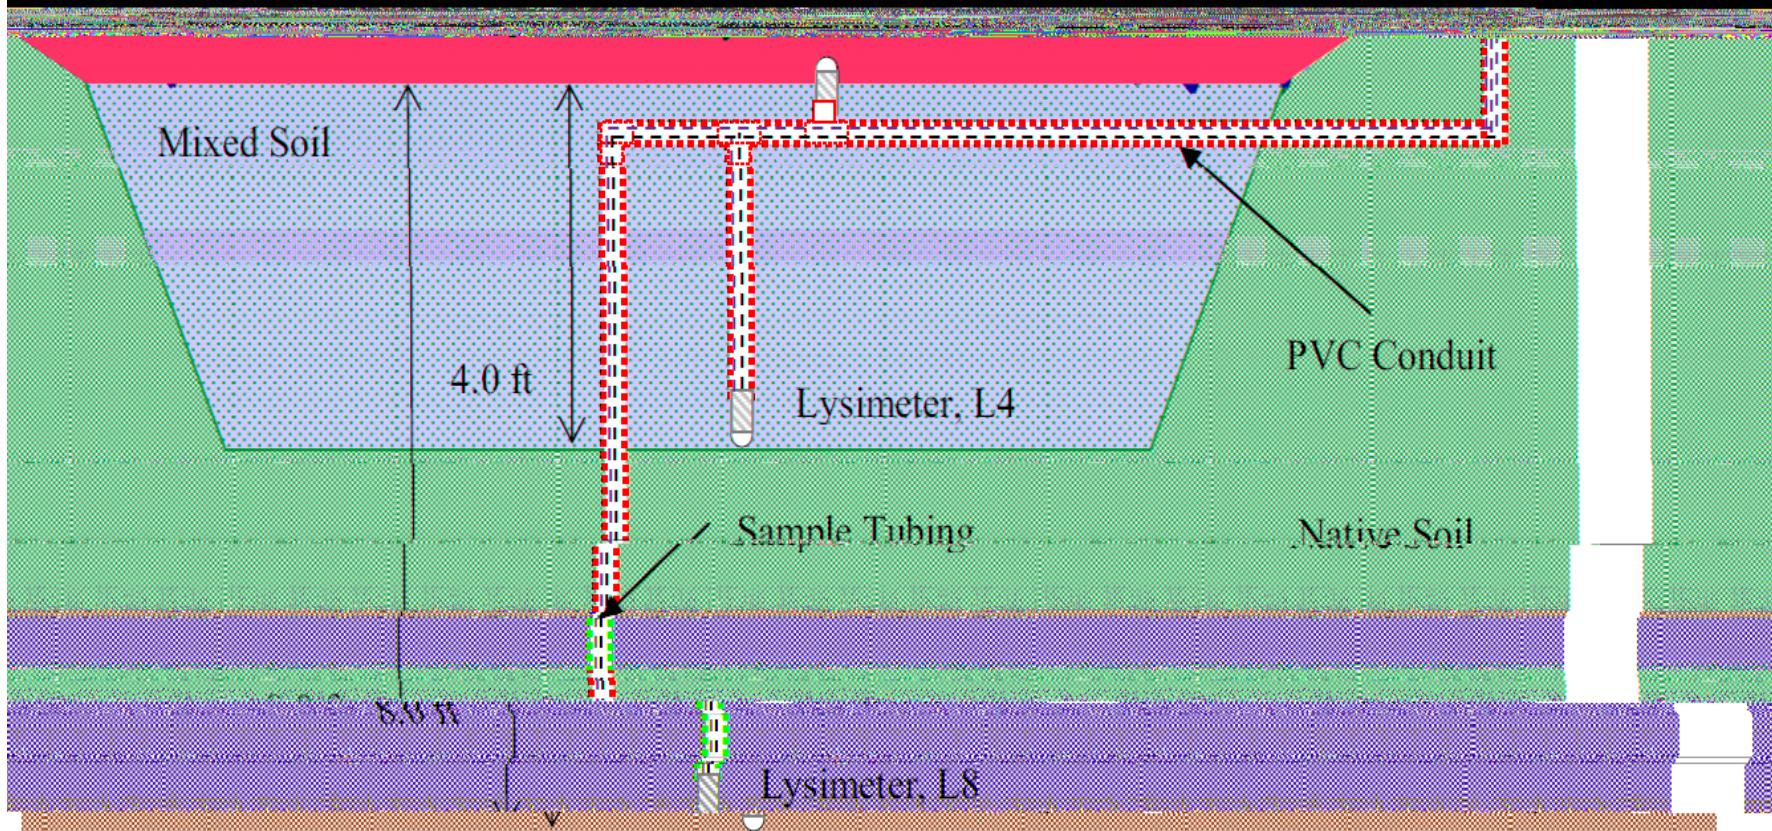
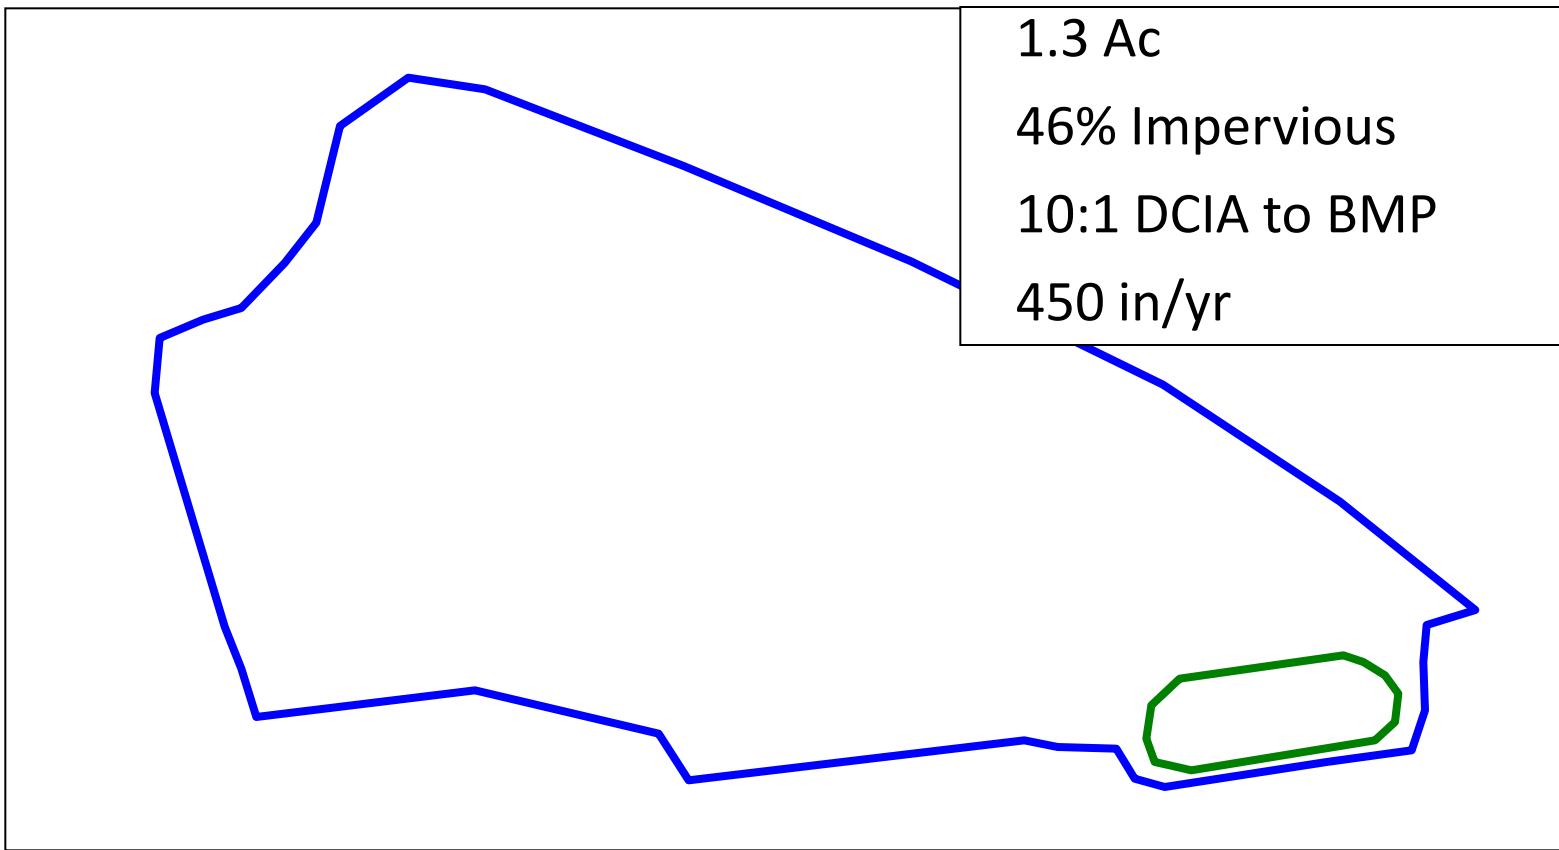
BioInfiltration Rain Garden

Profile

Constructed in 2001

~4 ft excavation, filled with a 1:1 sand/soil mixture

Planted with vegetation typically found along the eastern seaboard

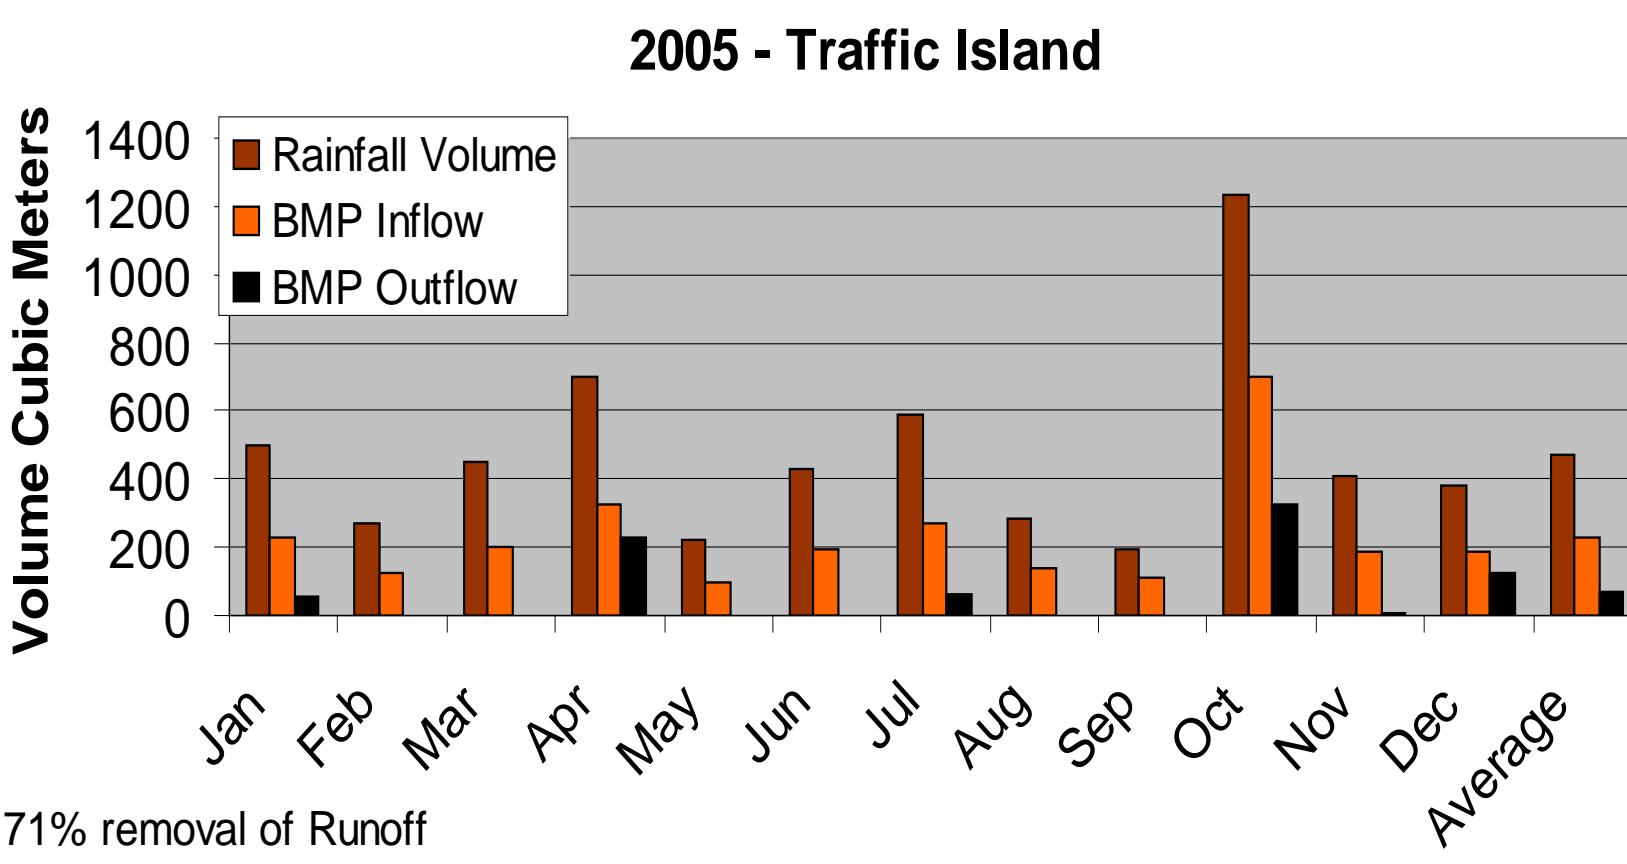
Hydrologic Performance

2007 Traffic Island Surface Water Analysis				
	# of Storms	Inflow	Outflow	Removal Efficiency
Water Quantity (1/2007 - 12/2007 Total)	19	983,843 L	185,117 L	81.2%
Water Quantity (1/2007 - 12/2007 Sampled)	17	943,874 L	185,117 L	80.4%
Total Phosphorus (TP) as P	17	614.4 g	142.4 g	76.8%
NO ₂ as N	16	55.0 g	13.6 g	75.2%
NO ₃ as N	16	505.3 g	46.7 g	90.8%
Phosphate (PO ₄) as P	16	131.0 g	30.7 g	76.6%
Chloride (CHL)	16	325.7 kg	0.3 kg	99.9%
Total Suspended Solids (TSS)	17	187.7 kg	1.4 kg	99.3%
Total Dissolved Solids (TDS)	17	156.2 kg	7.2 kg	95.4%
Total Copper	8	21.0 g	2.3 g	89.0%
Total Lead	10	13.5 g	0.7 g	94.7%
Total Cadmium	10	1.9 g	0.1 g	97.3%
Total Chromium	12	21.8 g	0.8 g	96.1%

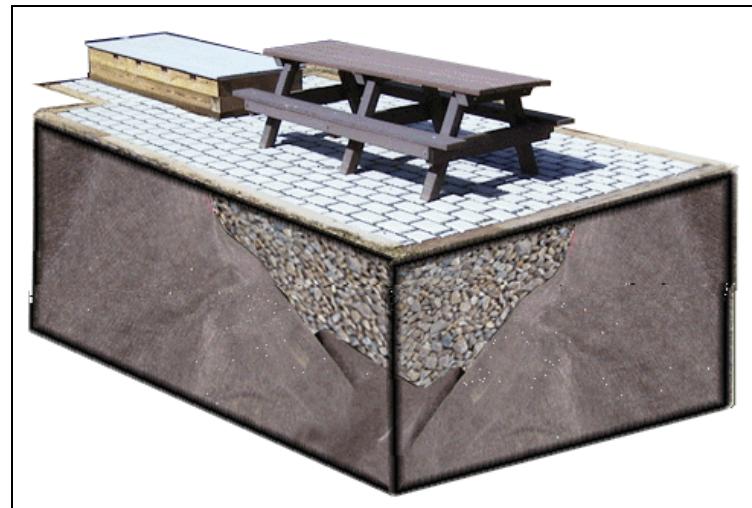
Infiltration Trench (IT)

Depth measured using a pressure transducer

Rainfall and temperature measurements

Intentionally under (poorly) designed...

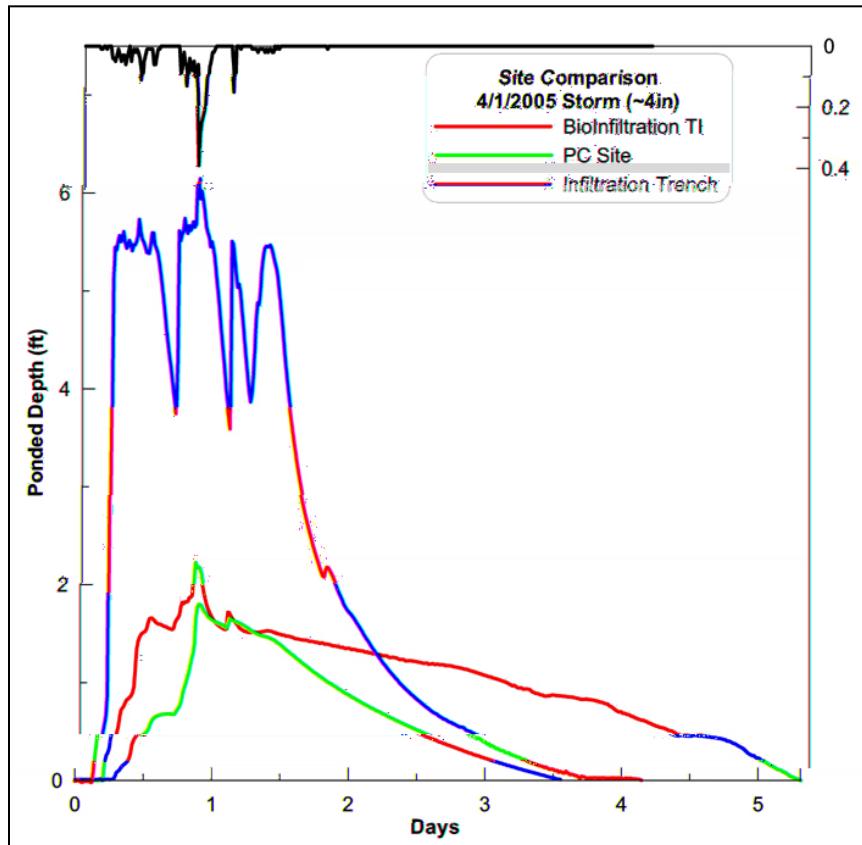
Not always constant with depth

Each BMP has its own characteristic recession limb (shape) from storm to storm

Can be compared over time (longevity)

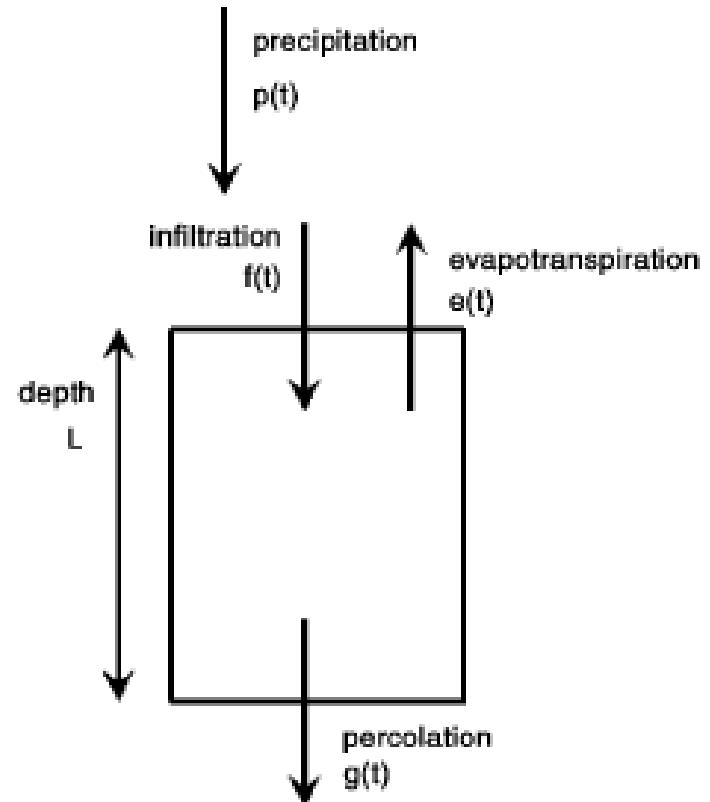
Figure 1. The root zone as a lumped hydrological system

The Model Brocca CFM

- Brocca et al, 2008

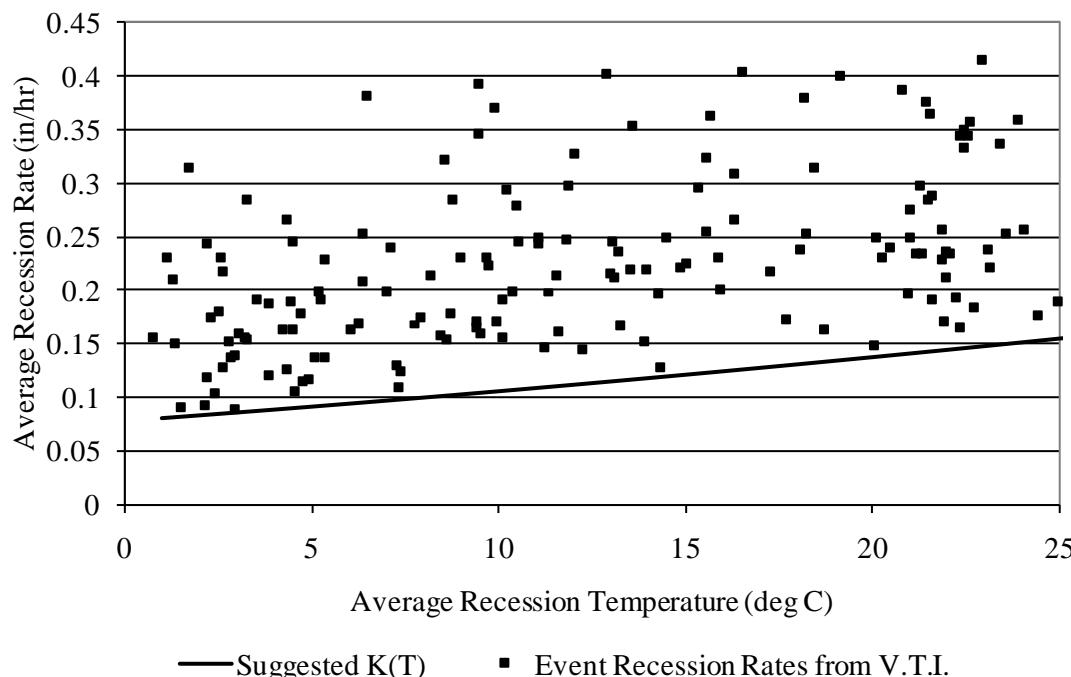
Determining $K(T)$ from data

- Look at the infiltration eqn... dD/dt is always greater than K . This recession rate will approach K for low values of T (high moisture content).

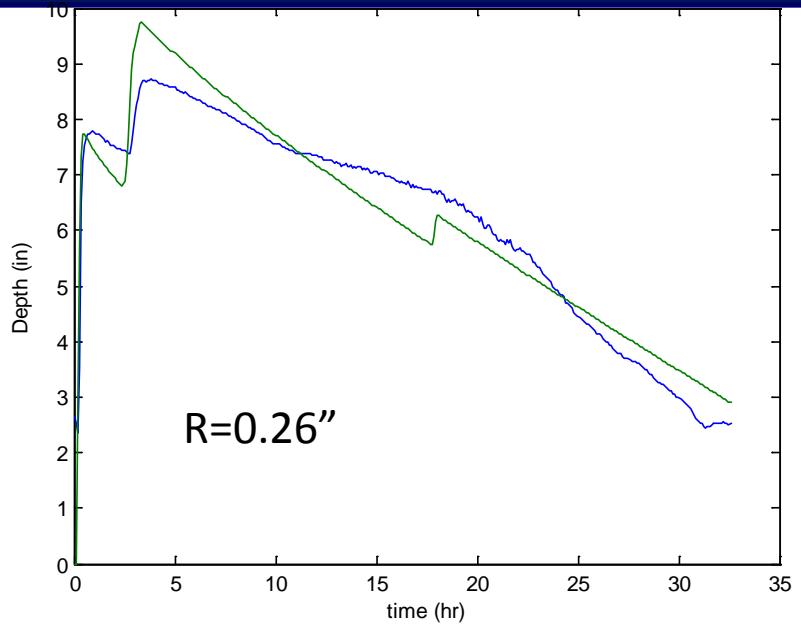
7182006 CN1=99.1 la1=0.04 CN2=90.2 la2=0.50 psi=15

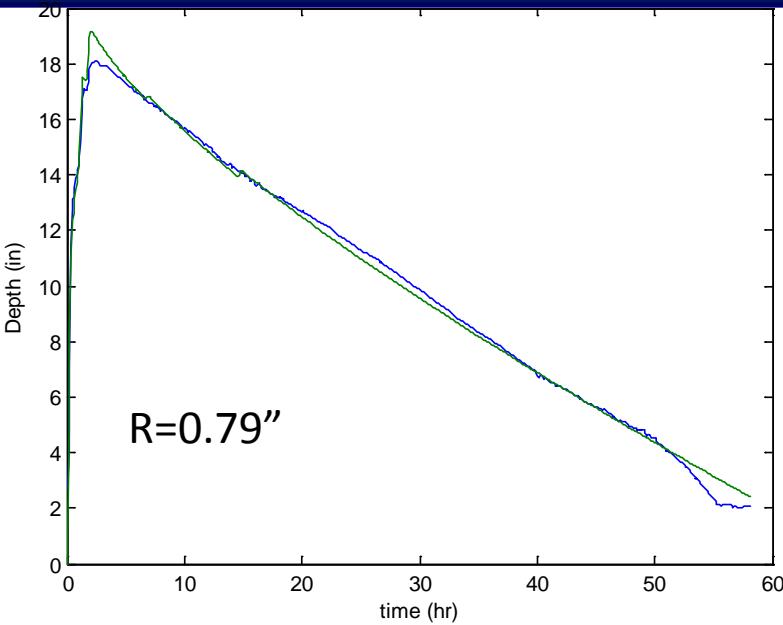
7232004 CN1=97.9 la1=0.04 CN2=85.0 la2=0.44 psi=47

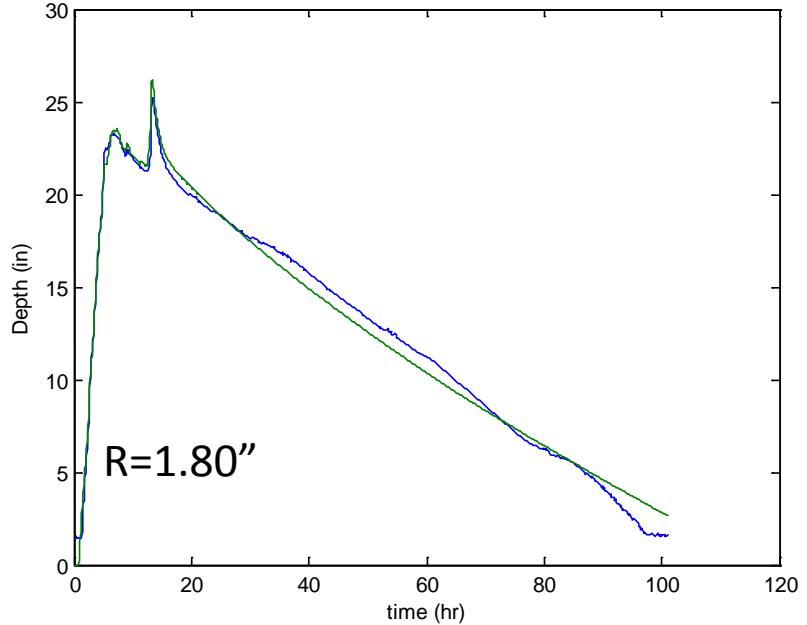
12242003 CN1=96.9 la1=0.04 CN2=69.9 la2=0.09 psi=101

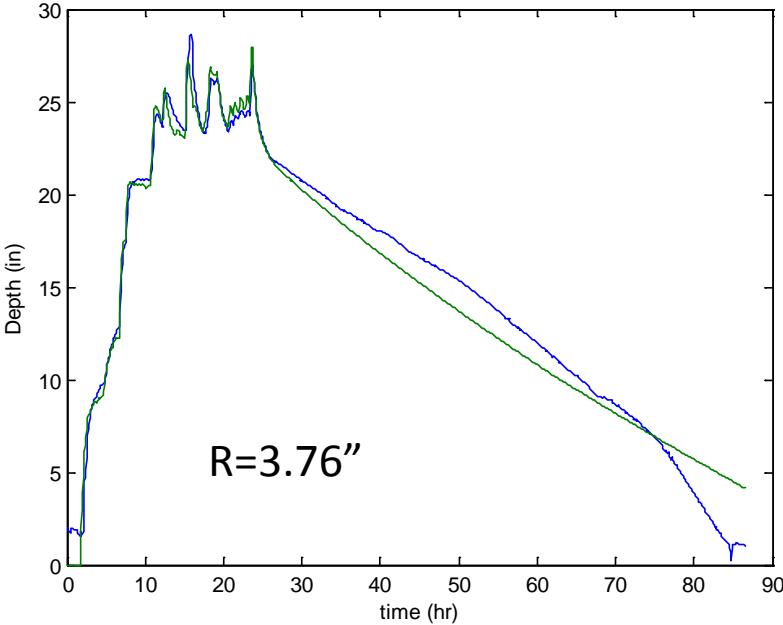
10262007 CN1=98.9 la1=0.04 CN2=85.7 la2=0.45 psi=163
